ESSEX COUNTY VELO REPORT TO THE GLOUCESTER PLANNING & DEVELOPMENT COMMITTEE AND CITY COUNCIL

Work Done as of 16 January 2013

Point-by-Point Address of Mr Roark's Photographic Evidence to P&D Committee 7 November 2013

EFFECTS OF THE GRAN PRIX OF GLOUCESTER ON THE SAM PARISI BASEBALL FIELD

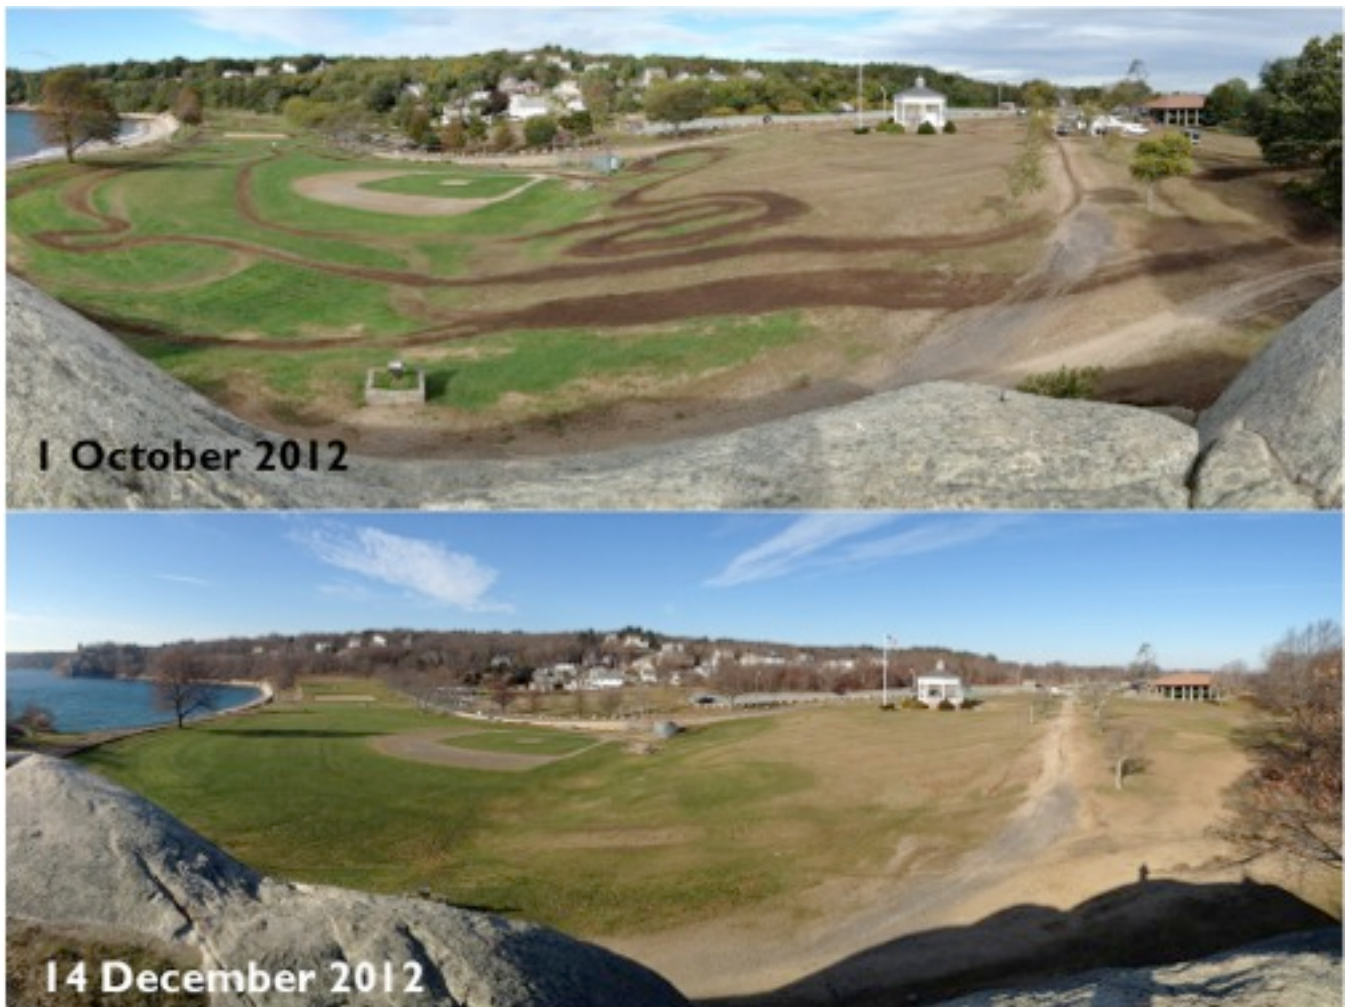
Photo 1 - Panoramic photos taken atop Tablet Rock showing the park shortly after the event on 1 October 2012 and several weeks later on 14 December 2012.

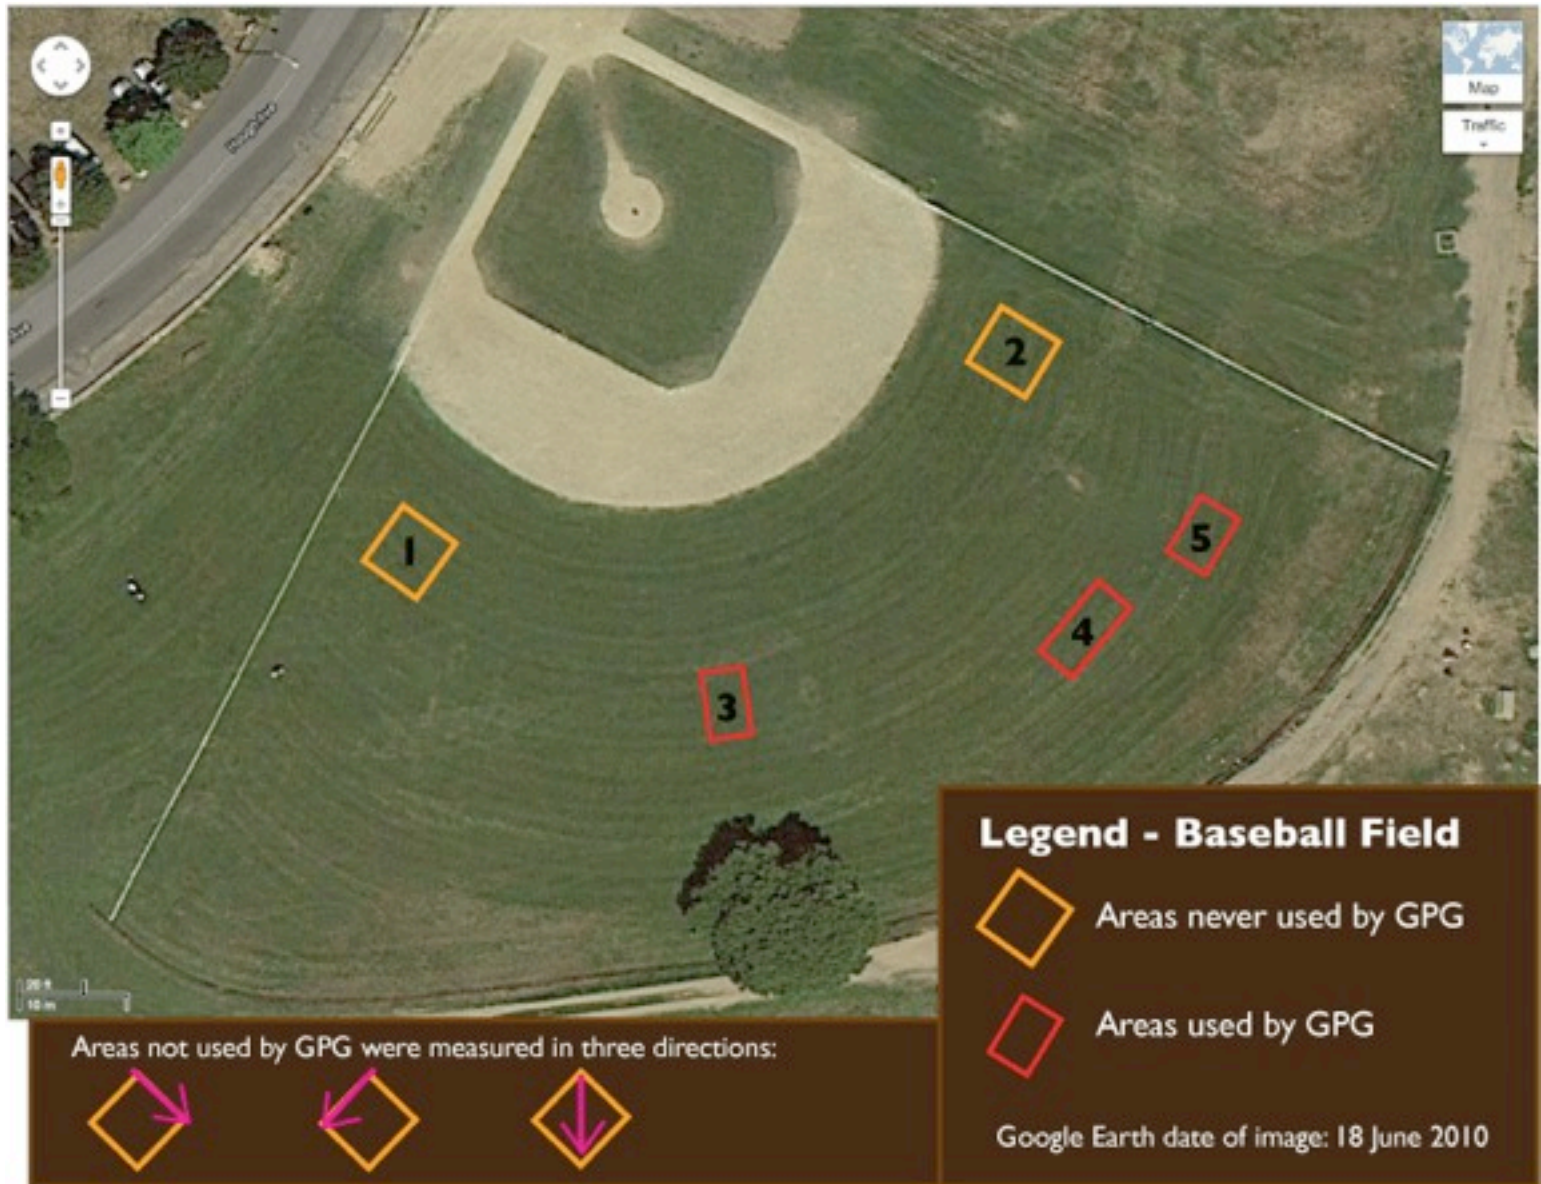
Figure A - overview of the ballpark showing test areas. Areas 1 & 2 have never been used by GP Gloucester. Areas 3, 4 and 5 have been used by GP Gloucester in 2012 and other years.

The areas we measured that are unused by the race are located 20' towards the outfield on the 1st and 3rd base lines. The race has always kept the course in the outfield and these areas have never been included in Gran Prix race courses. (see Figure A showing areas 1 and 2).

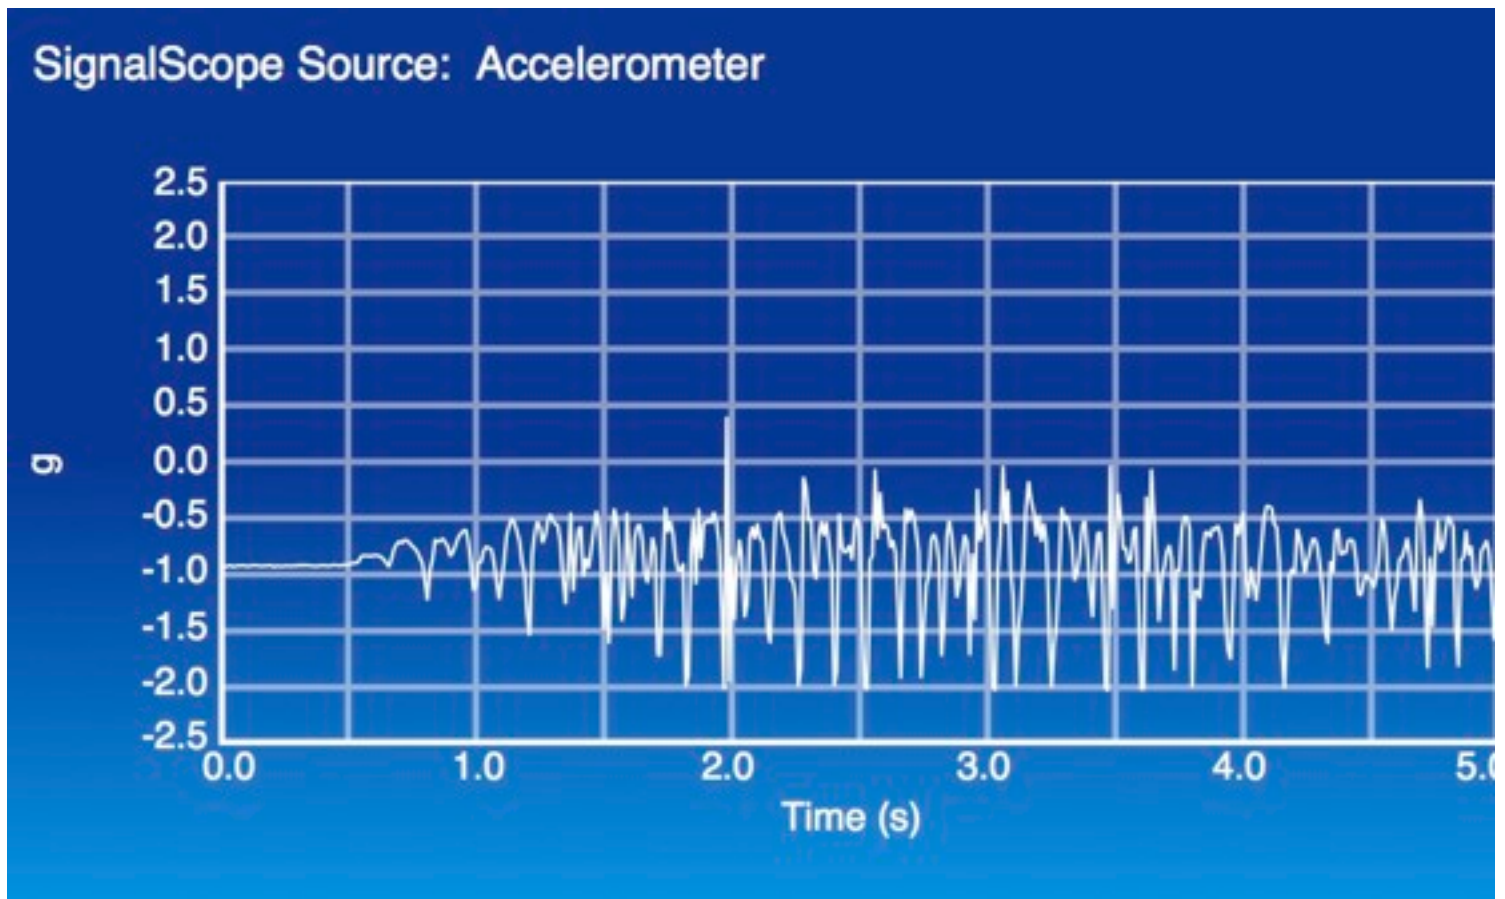
Figure D - Measurements in Area 1 made 20' away from first base running perpendicular to the foul ball line

The final measurement line for Area 1 shown in Figure D shows a 2g swing. There's a deviation at 2.0s by 1g but otherwise there are no significant ruts.

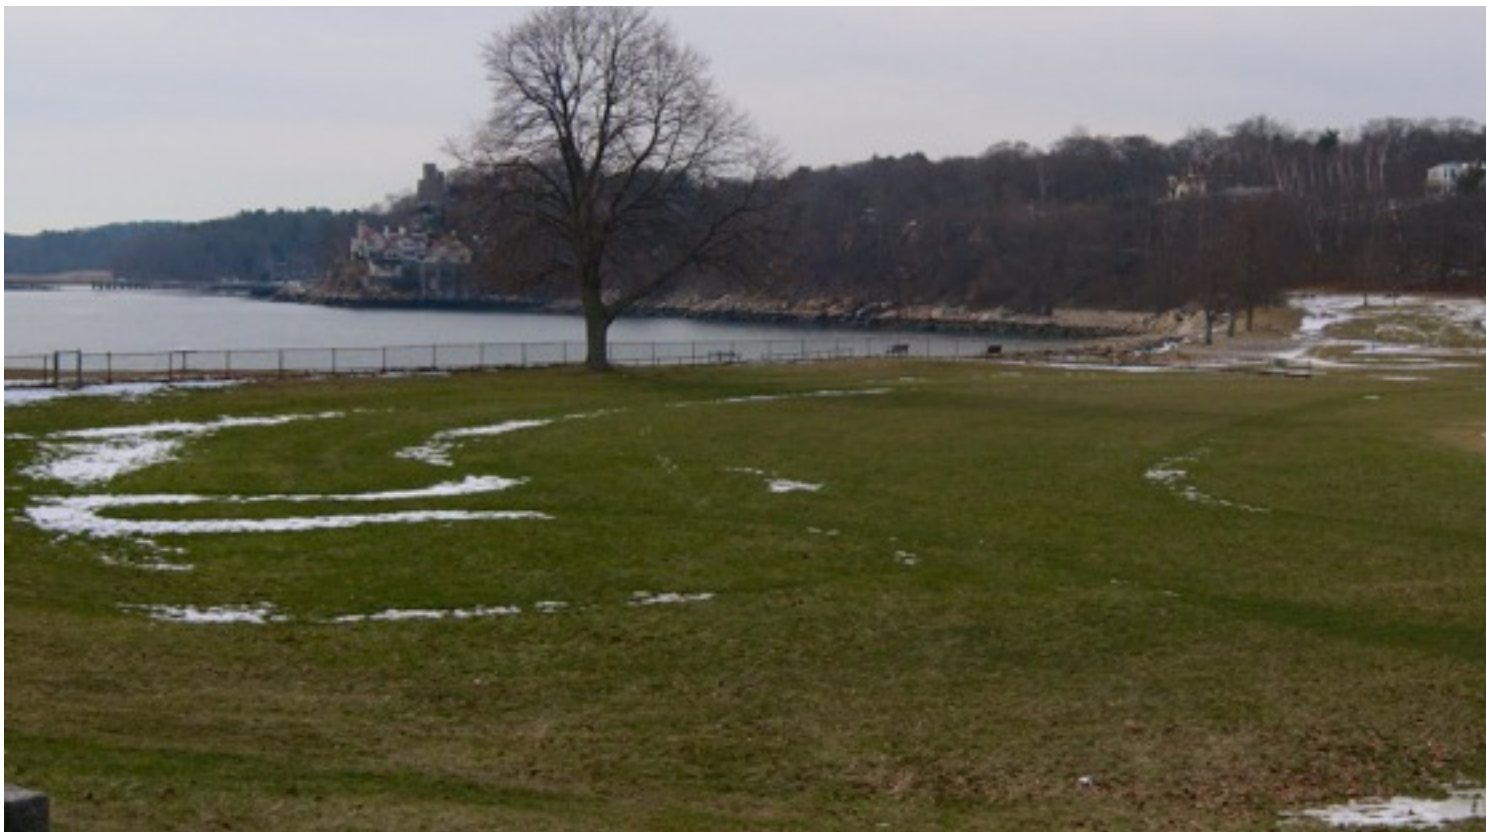
Photo A - Section of the park where the course was S-shaped. The appearance was obvious however, measurements show the disturbance was not significant.

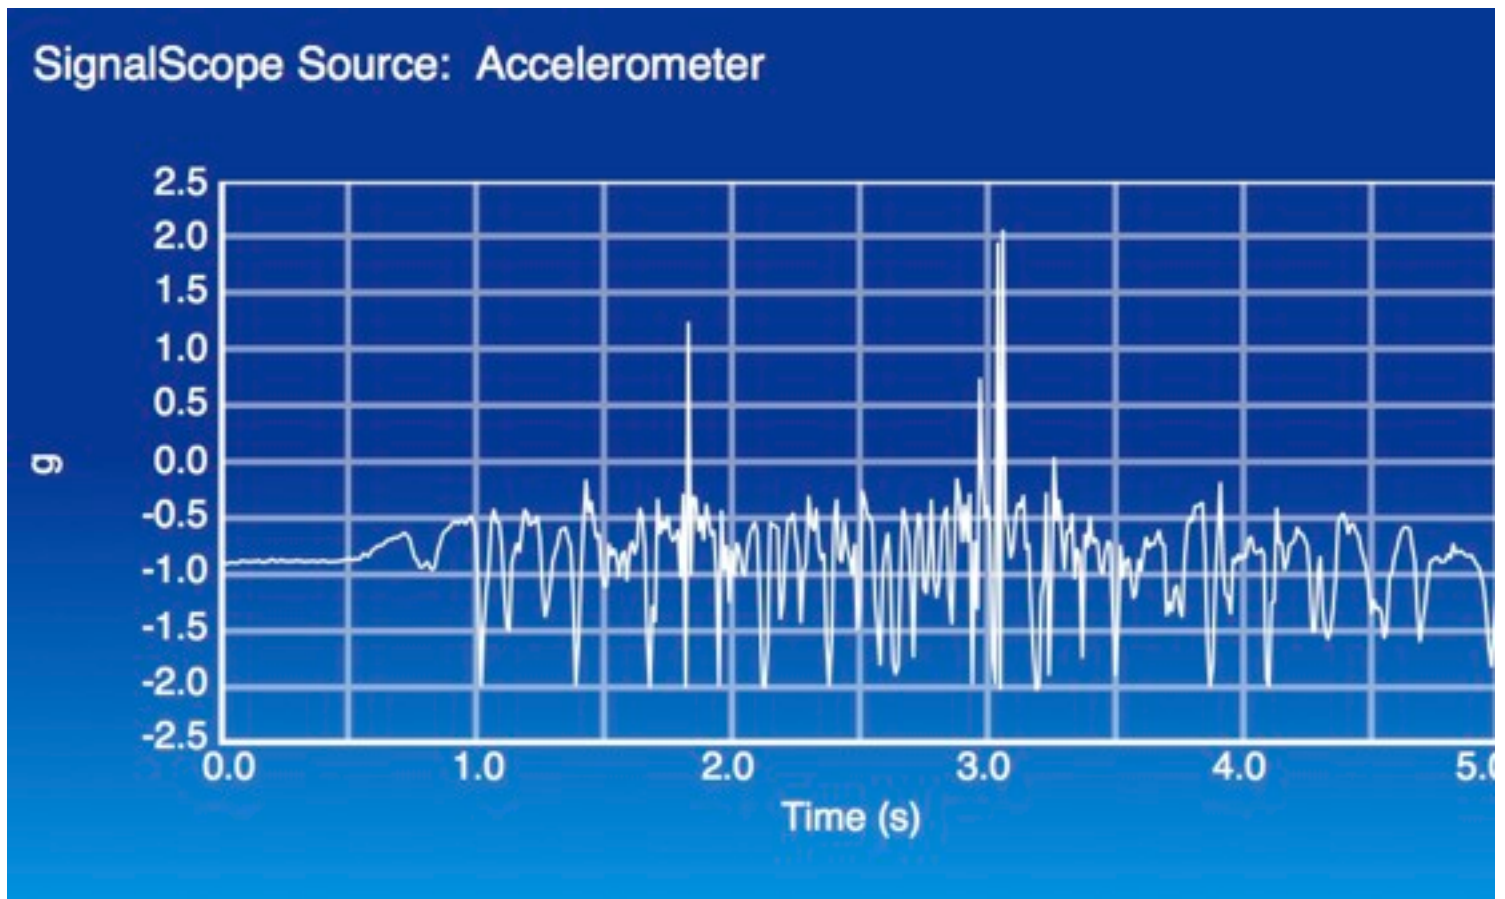
Figure 1 - Measurements in Area 5 approximately 25 yards away from the outfield fence towards third base

Area 5 is another section we've identified as needing additional repair. Approximately 25 yards from the outfield fence towards third base, our measurements show two significant deviations from the norm. (1.7s/2g and 3.0s/3g.)

We found that there were some ruts (areas where additional repair is necessary) from the 2012 race. Essex County Velo will work with the Director of the DPW to ensure that these sections of the park are repaired satisfactorily.

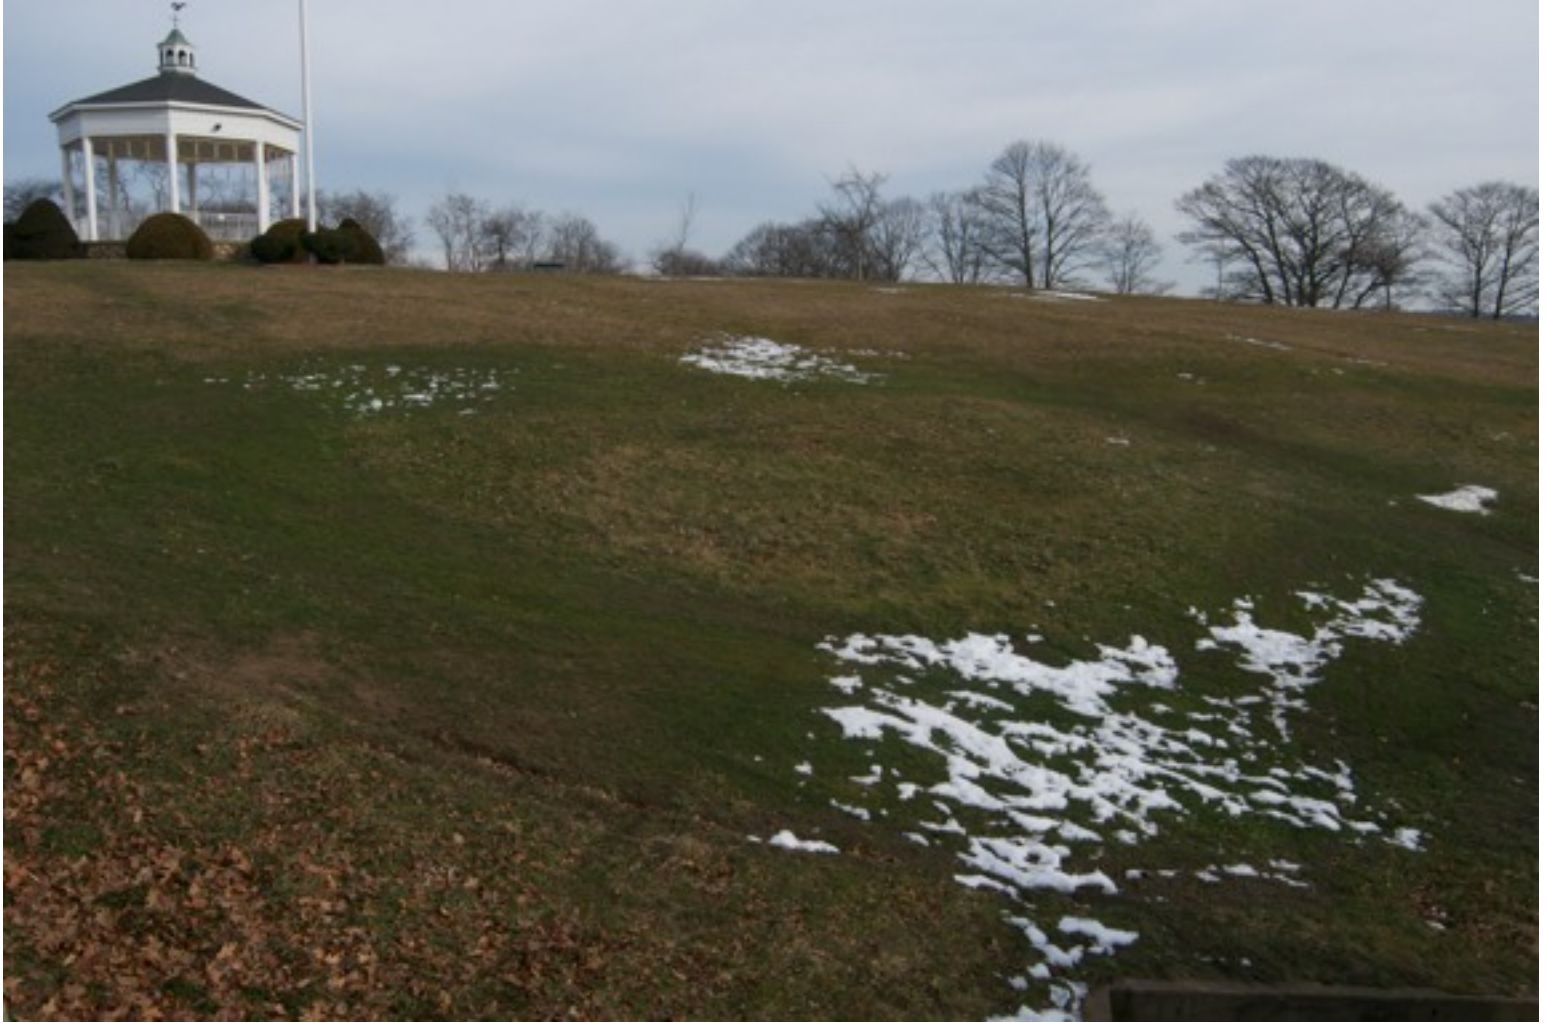
Investigation of the park on January 9 shows a vastly different situation. Grass has grown in nicely. The impact is minimal. We did however notice a rut behind the ball field backstop that is about a 5 yards long and several inches wide. There are also some smaller ruts in that were discovered. We will instruct Wolf Hill to repair.

Addendum Photo 1: Area of hillside behind the ball field backstop. The majority of the path has grown with the addition of new seed. However there are a few ruts which require work. In the foreground, the rut is about 5 meters long and several inches wide.

1. Additional grass seed on the hill behind the baseball field backstop, repair ruts. Loam as needed.
2. Inspect baseball outfield for any ruts or unevenness - repair as necessary.
3. Grade Lucy Davis Walkway with stone dust and remove pile of dirt at the base of the wall.
4. Rake, seed and stabilize the area on the hillside above the Lucy Davis Walkway.
5. Re-seed areas near the tennis court gardens and the apple orchard. Repair few remaining ruts.

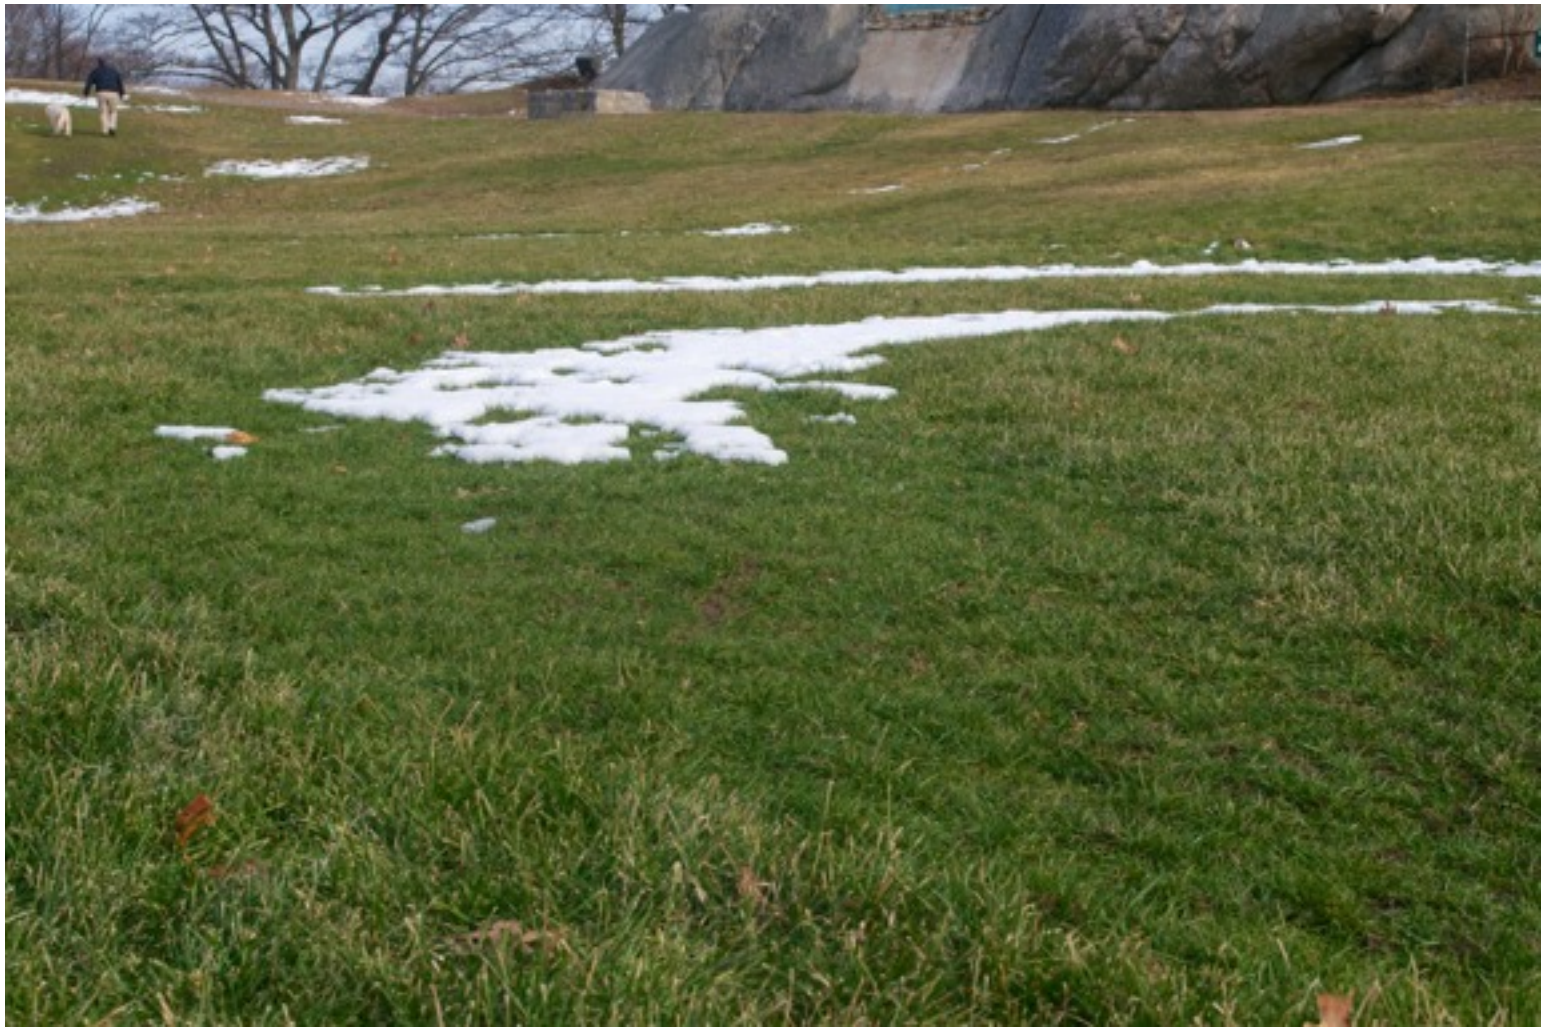
We have identified a few ruts in the outfield that require attention. However, our measurements show, that the majority of the track is as smooth as the unused portions of the field.

Addendum Photo 2: Close-up of an area in left field of the Sam Parisi ball field. Several ruts remain and will be repaired. Note that the newer grass is shorter and brighter green than the surrounding area. For the most part, this is visual in appearance but the ground smoothness differs little from areas unused by the race.

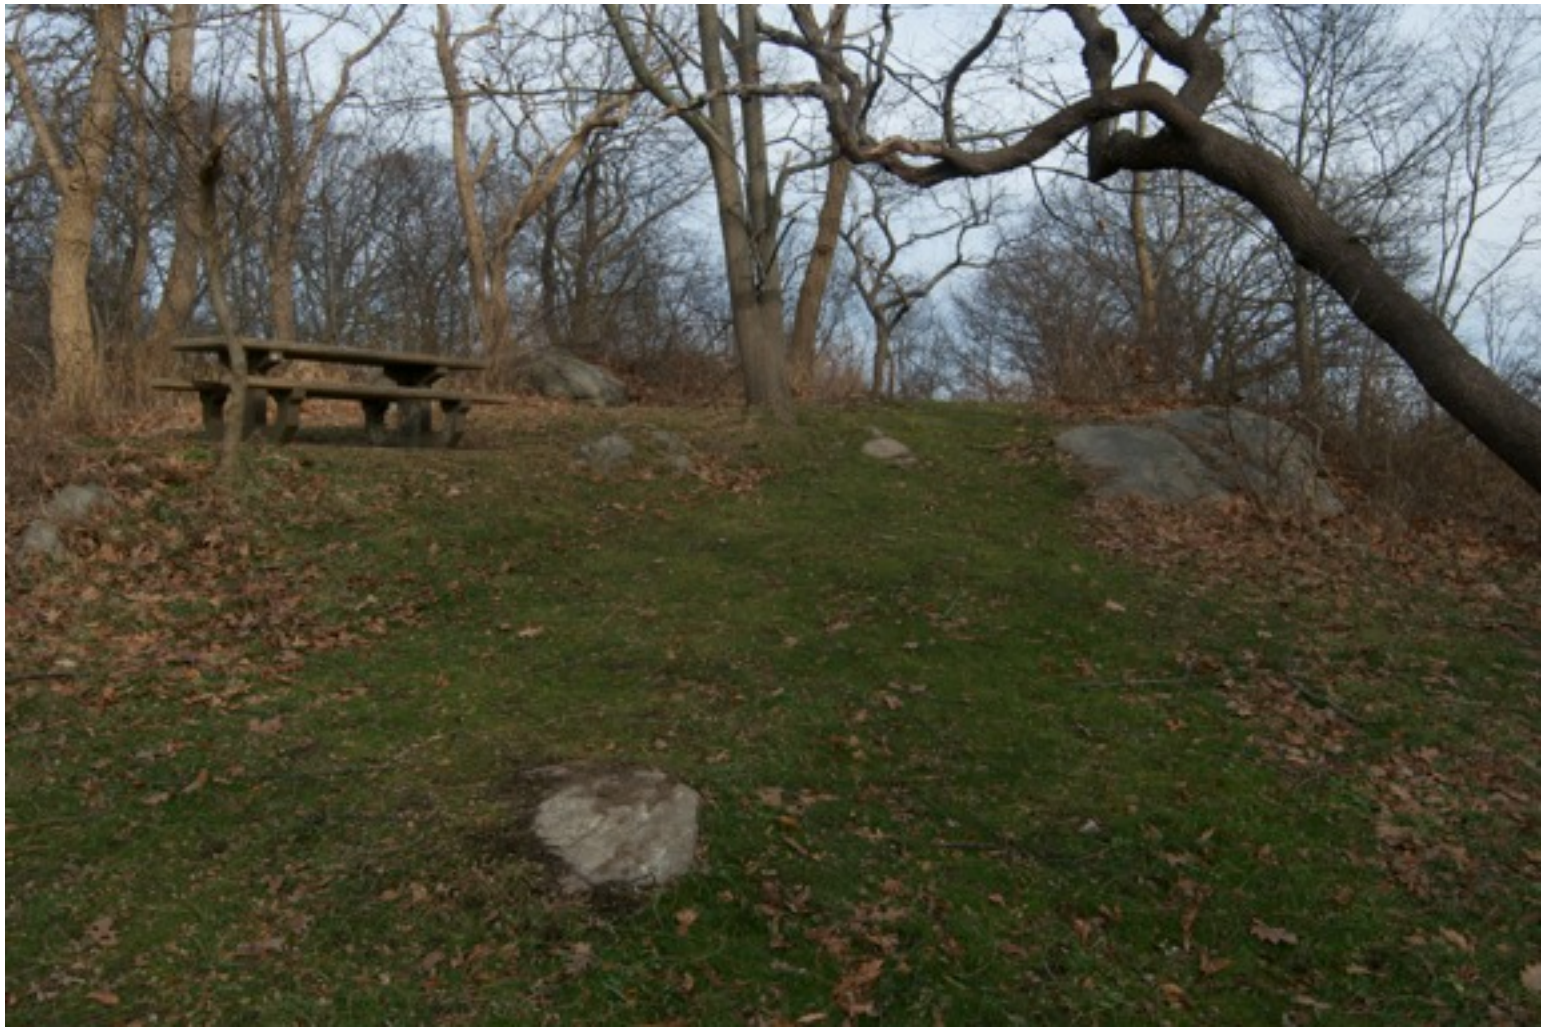
Addendum Photo 3: Area used on by the race to connect a path adjacent to the playground to a lower elevation near the picnic tables by the Visitor's Center.

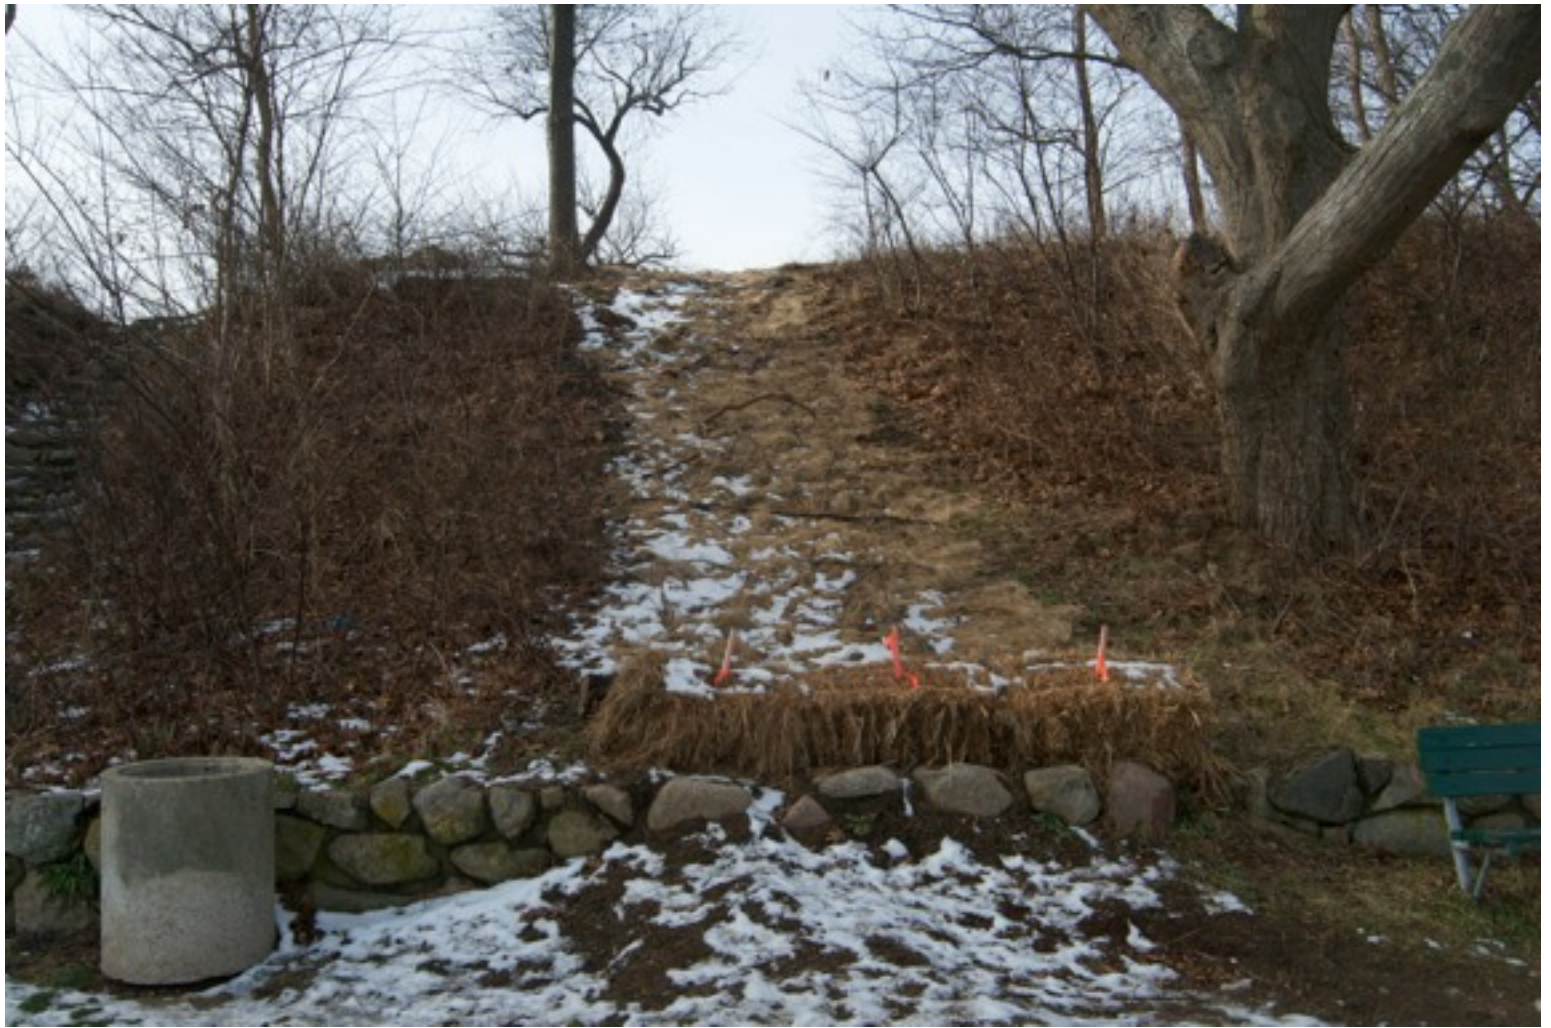
This section has been used for the last three years as a course feature (called a run-up in cyclocross parlance). The first two years this feature was used, growth of the cover crop grew back significantly on its own. No work was needed for this section to recover. With the amount of rain during the 2012 event, this section did not grow back and needs to be addressed. As of this writing, the hill has been dressed to avoid any erosion. Likely plan of action for the spring is to replenish the cover crop by planting winter rye to stabilize the area.

Addendum Photo 4: Shows the run-up section connecting the Lucy B Davis Pathway to the playground.

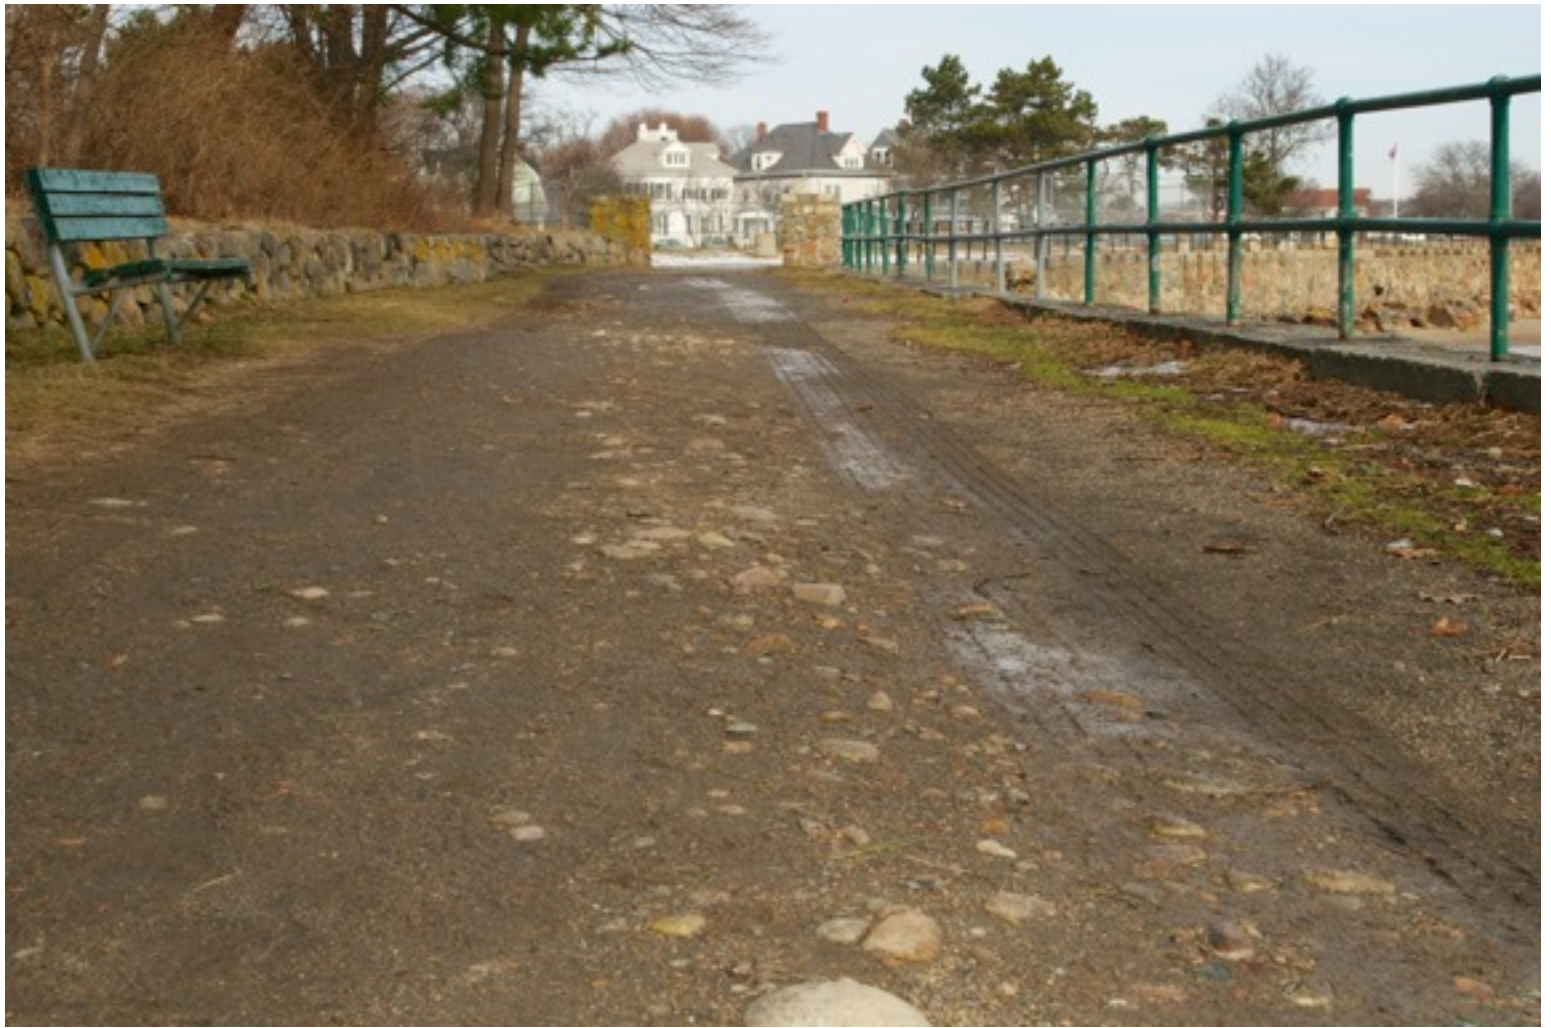
While Mr. Roark's numbers sound daunting, they are not proof that damage exists on the path due to the bicycle racing. Firstly, as an engineered gravel path, there is/was no topsoil. Of the path degradation concerns noted in various studies regarding the impact of (mountain) biking on trails: muddiness, displacement, erosion, compaction; most of these attributes (muddiness, displacement and erosion), do not apply. Compaction might be the only issue since the path is level, solid and not muddy. Mr. Roark's contention that "It is not good for walking" outstanding, there is very little evidence of damage attributed to the path by bicycles.

Addendum Photo 5: The Lucy Brown Davis Pathway is a man-made gravel path. No evidence of damage due to bicycles is present. The race organizers have offered to improve the quality of the path as outlined in the accompanying report.

Regardless, Essex County Velo is prepared to help restore the path for the enjoyment of all parties. We propose a re-grading and smoothing of the Lucy Davis pathway as well as the addition of stone dust. Wolf Hill thinks this will improve the path for all parties. We've received a quote from Wolf Hill and will work directly with the Parks Department in its implementation

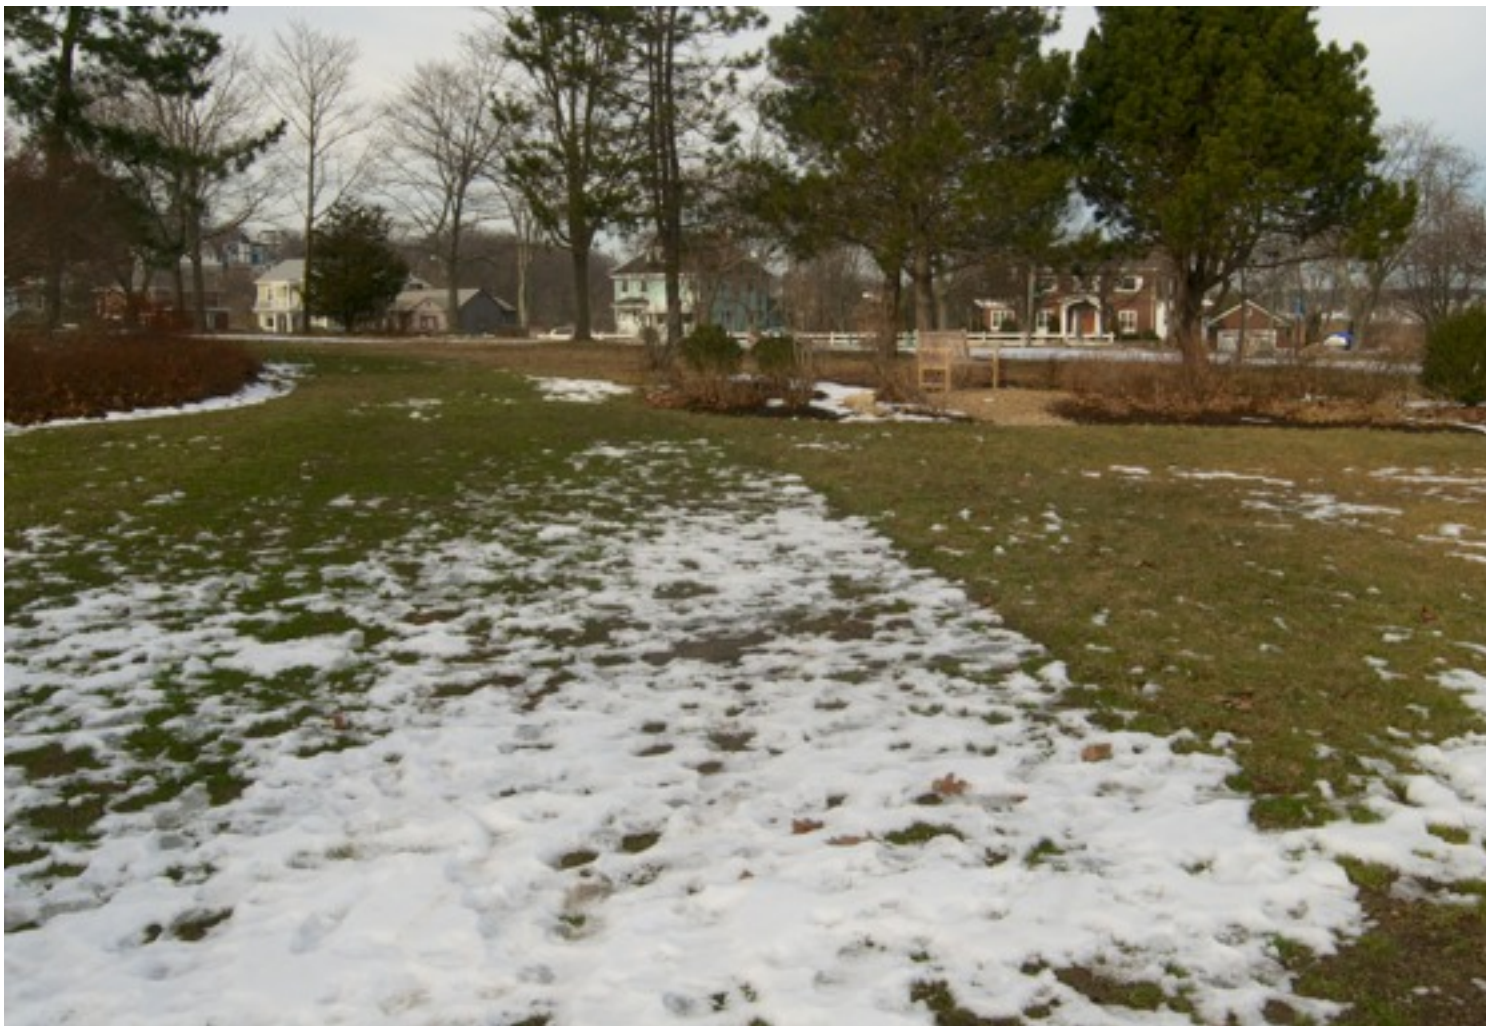
Investigation of the park on January 9 shows a vastly different situation. Grass has grown in nicely. The overall impact is minimal. There are a few ruts remaining and we will work with Wolf Hill to repair. Recognizing the sensitivity of residents to this area, the bike race, if allowed to occur in the future, will not use this section for its course.

Addendum Photo 6: Area by the Rose Garden. Much of the grass has come back, though some ruts remain and will be repaired. Future editions of the Gran Prix of Gloucester will not use this section of the park.

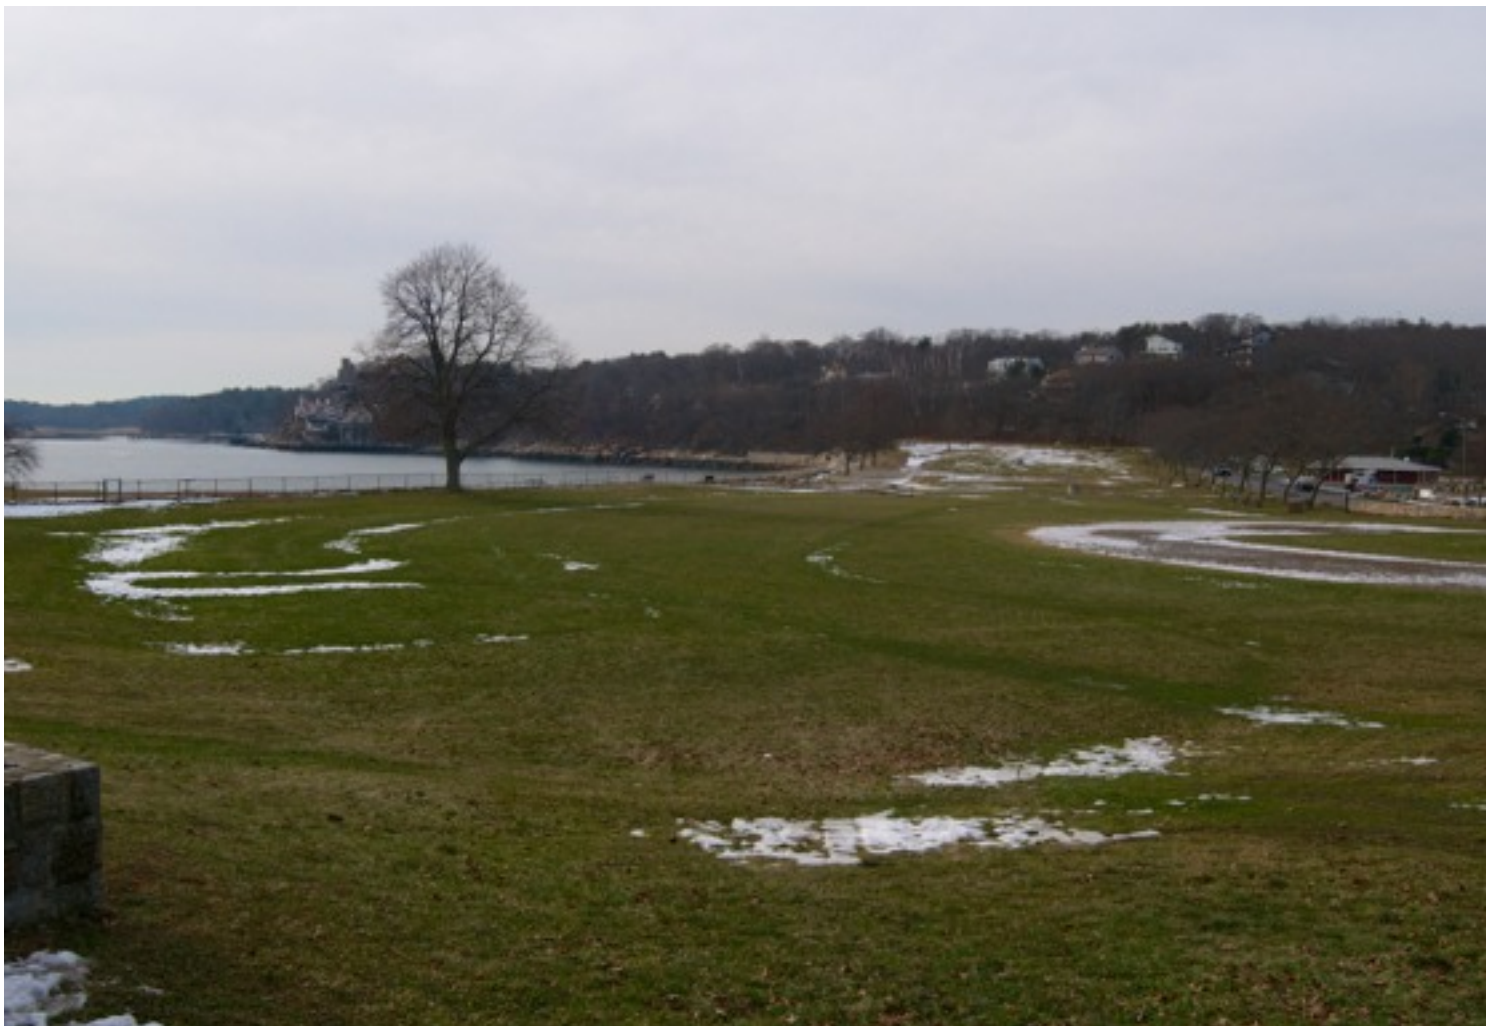
Addendum Photo 7: View of the Sam Parisi Baseball Field from atop the adjacent hillside. The majority of the path used by the race is growing fresh grass. The ruts that do remain will be repaired before the start of baseball season.

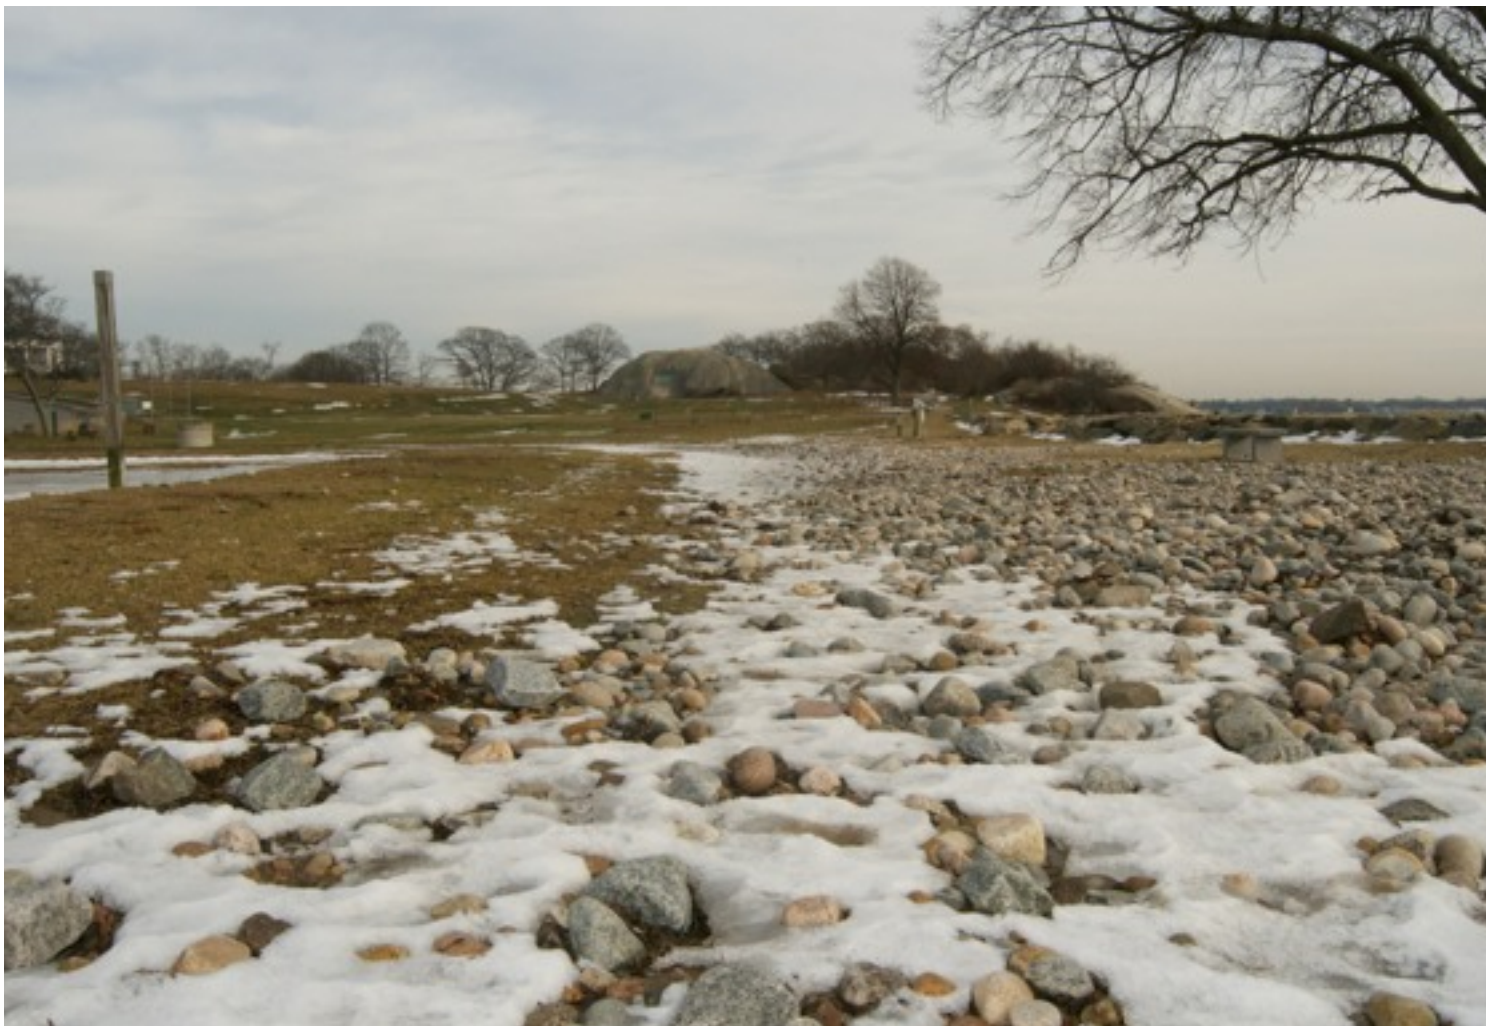
Unable to determine how this area of the park has healed due to damage incurred during winter storm. Rocks from the beach are strewn all over the grass between the volleyball court and Cressy's Beach.

Addendum Photo 8: Area between Cressy's beach and the volleyball court shows recent damage by December storms.

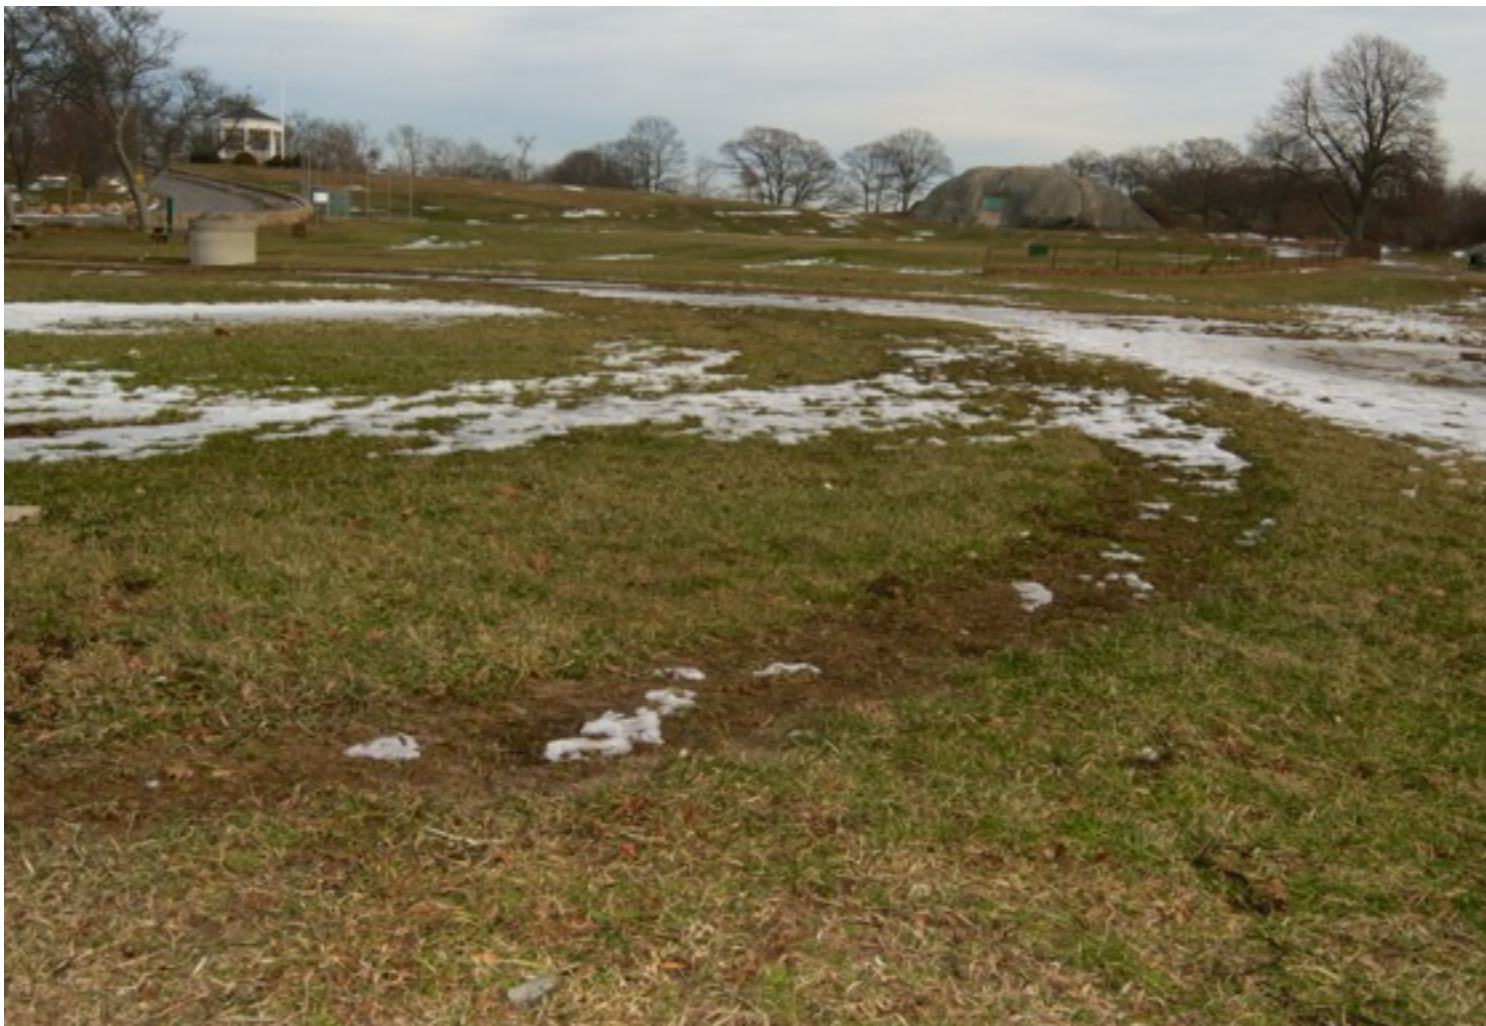
Addendum Photo 9: Lower Field across from the Cupboard shows an area with ruts. These will be repaired by the race organizers.
