ESSEX COUNTY VELO REPORT TO THE GLOUCESTER PLANNING & DEVELOPMENT COMMITTEE AND CITY COUNCIL

Work Done as of 16 January 2013

Point-by-Point Address of Mr Roark's Photographic Evidence to P&D Committee 7 November 2013

EFFECTS OF THE GRAN PRIX OF GLOUCESTER ON THE SAM PARISI BASEBALL FIELD

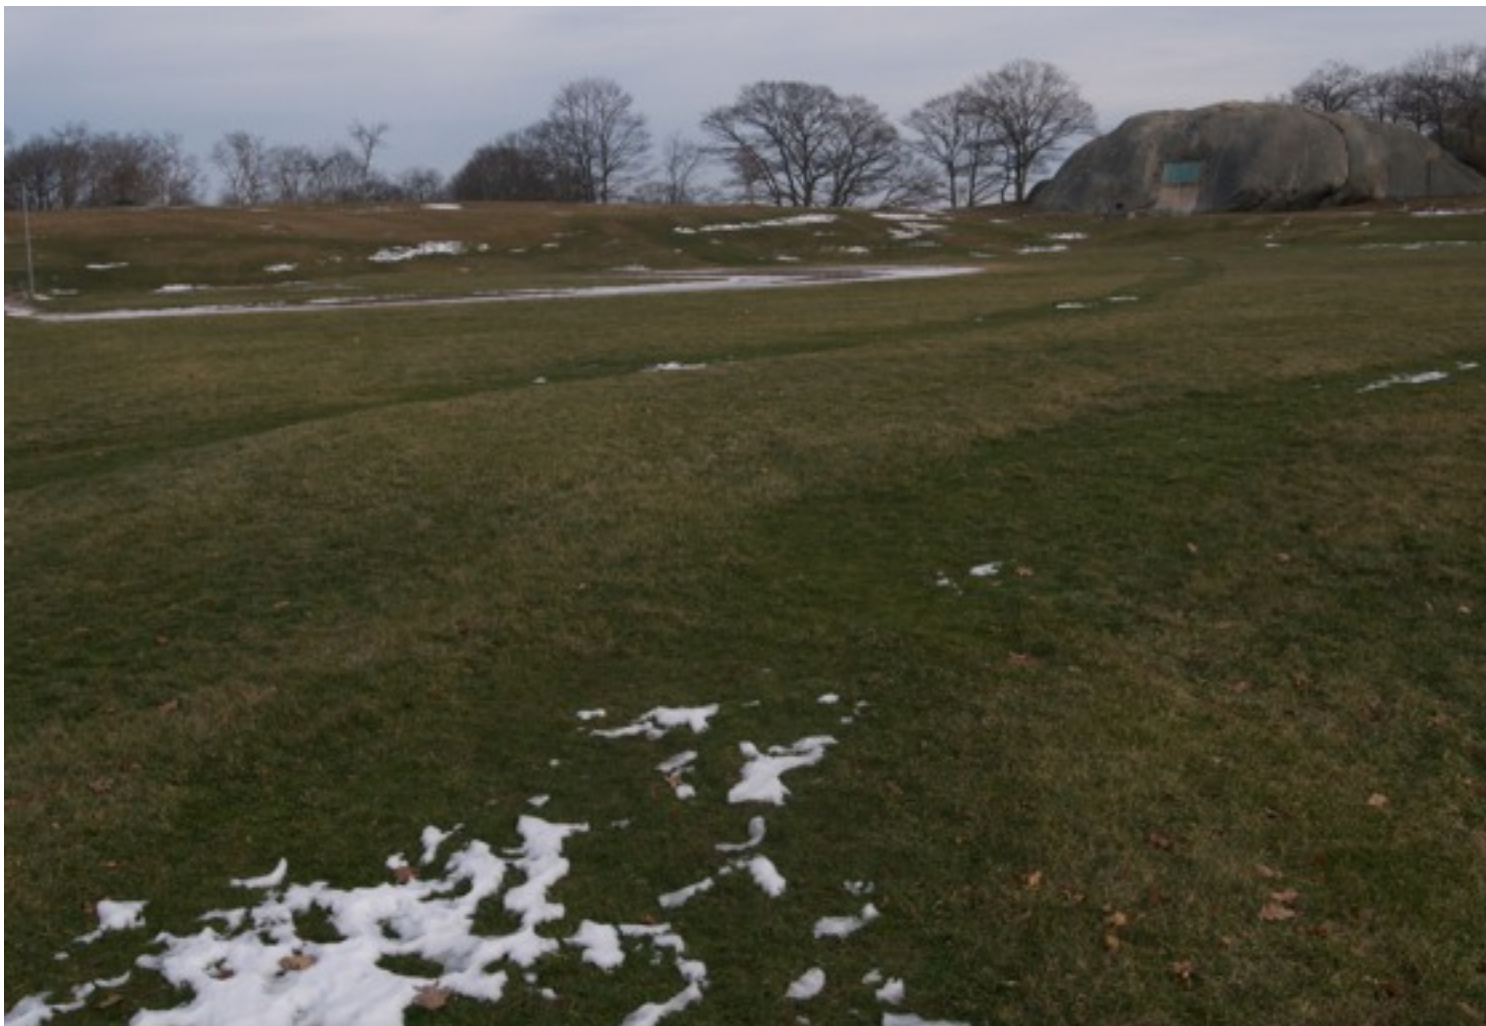
Addendum Photo 10: Right field in the Sam Parisi Baseball Field showing new grass growth.
